# Sliding Mechanism and Cause Analysis of Hanyuan Landslide in Sichuan Province

## Abstract

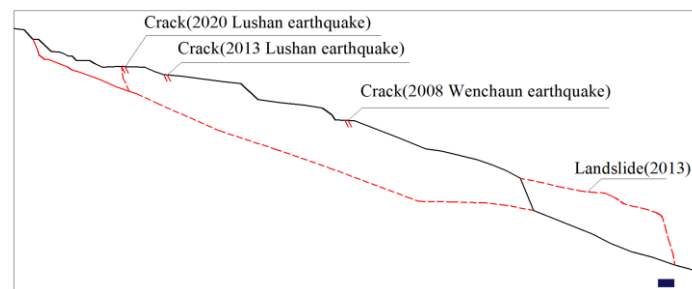
According to field survey visits, the H1-1 slide experienced three stages of deformation (Figure 4). The first stage : the formation stage of the free surface. In 1985, tension cracks appeared in the middle and upper part of the landslide, landslide occurred in 1989, but the scale is relatively small. After the landslide, new scarps (free surface) appeared in the back of the landslide until May 12,2008, no new deformation cracks were found on the slope.

Fig. 4 Diagram of deformation evolution in landslide stage

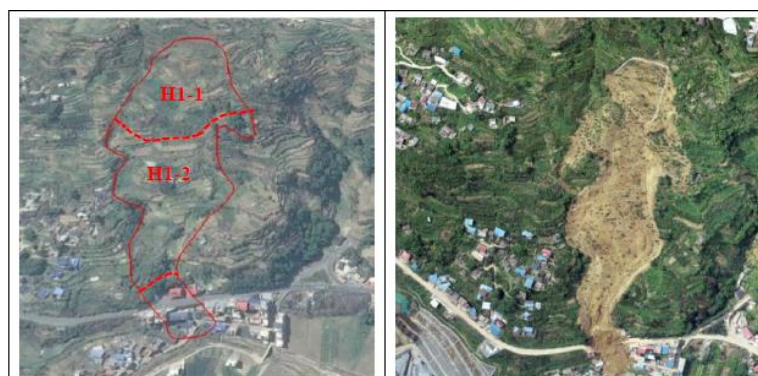
Fig. 5 Comparison of satellite photographs before and after landslide sliding

From the analysis of satellite images before and after the landslide, before the landslide sliding, the H1-1 landslide is a high and steep slope ( Figure 5), which is ladder-like. After the sliding, it is a flat slope, and the terrain changes greatly. The topography of H1-2 sliding body is similar before and after sliding (Fig. 5), and only changes after sliding and stacking in the central platform area.

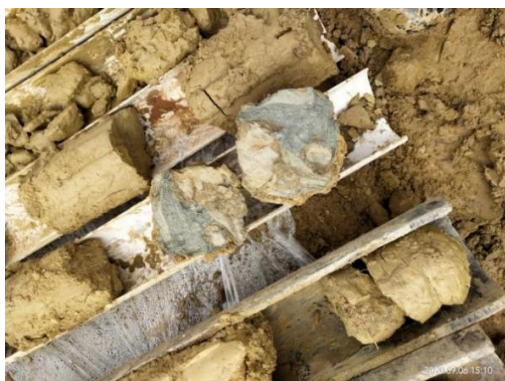
From the historical analysis of landslide deformation, the deformation of H1-1 landslide has gone through the process of initial deformation, intensified deformation and progressive sliding. H1-2 landslide sign of H1-2 landslide in the three stages. Drilling reveals that no deep deformation is caused after sliding loading of H1-1 landslide (Xigeda formation), and only the deformation and sliding of loose material in the shallow surface layer are generated after the material on both sides of the channel is repeatedly scoured and eroded. Drilling reveals that the soil near the sliding surface has serious extrusion deformation traces (Figs. 6 and 7).

Fig. 6 Extrusion deformation of rock mass near sliding zone

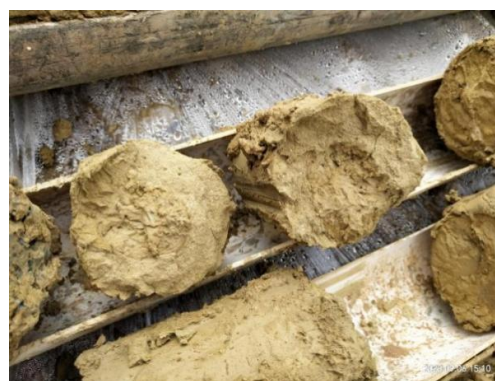
Fig. 7 Extrusion deformation of soil near sliding zone

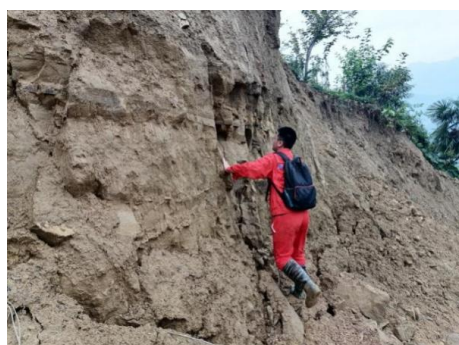
Landslide cover: after landslide sliding, it is re-stacked to form landslide cover, with slope direction of  $20^{\circ}$ , elevation of 875–1035 m, height difference of 160 m, and main sliding direction of  $20^{\circ}$ . The landslide structure is loose, the accumulation is disorderly, and the cracks on the slope are developed strongly (Fig.12). However, it is irregular. Due to the different sliding distances of the landslide in each block, many drum hill platforms, uplifts and depressions are formed on the landslide. The drum hill platform on the left side of the middle and upper part of the landslide is particularly obvious, and the water accumulation depression is formed on the right side of the middle part of the landslide. The back wall of the landslide forms up to 16 m staggered ridges (Figure 9) with a semi-circular

Fig. 9 Backwall of landslide

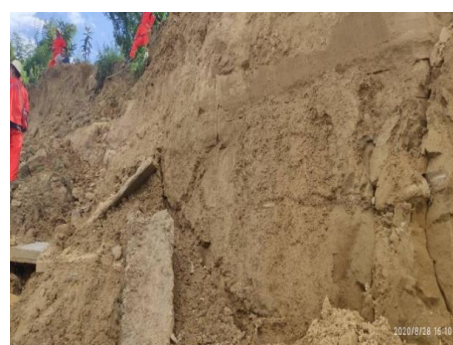
distribution. The upper part of the ridge is a residual slope containing gravel clay silt, and the lower part is Xigeda siltstone, clay rock and fine sandstone. Clear scratches can be seen on both sides and posterior walls ( Figures 10, 11 ).

Fig. 10 Right Sassafras mark of landslide

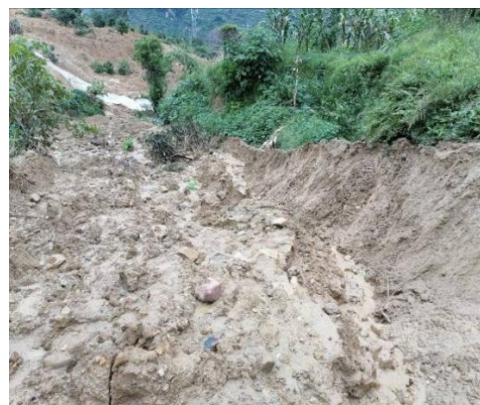
Fig. 14 Newly formed gullies on slides
