# Sliding Mechanism and Cause Analysis of Hanyuan Landslide in Sichuan Province

## Abstract

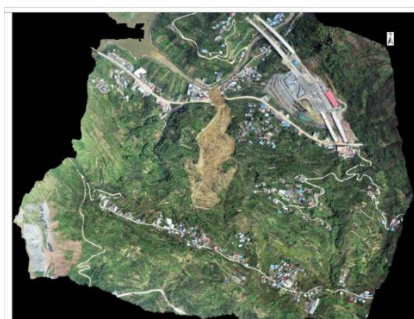
The landslide in the study area is located in Fuquan Town, Hanyuan County, Sichuan Province, about 16 km from Hanyuan County and 9 km from Fuquan Town. The geographical coordinates are E:102°38', N:29°22'. The elevation of landslide area is 848m~1061m, and the relative elevation difference is about 213m. The original landform of the landslide is a platform ridge slope, and the slope direction is NW16°–NE28°. South side is flat narrow ridge, width 70m~100m, slope down the development of two secondary platform, platform between steep slope, slope 35~45°, stepped ridge, ridge height 1.5~4m. The 'V' shaped valley was developed on the west side, with the overall gully direction of NE15° and the maximum cutting depth of about 50 m (Figure 1).

Fig. 1 3D oblique photography model of landslide area

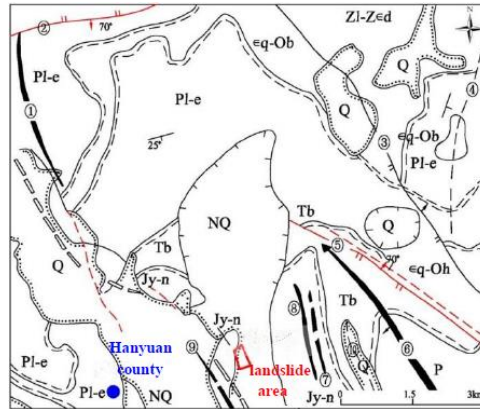
The landslide area is located in the junction and merger of the Qinghai-Tibet, Yunnan-Myanmar-Indonesia giant z' structure and the western Sichuan tectonic belt of the Neocathaysian system, and is affected by the southern end of the Longmenshan tectonic belt of the Cathaysian system. The geological structure is complex, and the folds and faults are developed. The main outcrops are Yuanbaiguowan Formation (Tb), Tertiary and Quaternary sediments (NQ), Longtan Formation-Emeishan basalt group (Pl-e) (Figure 2).

Fig. 2 Structural diagram of exploration area

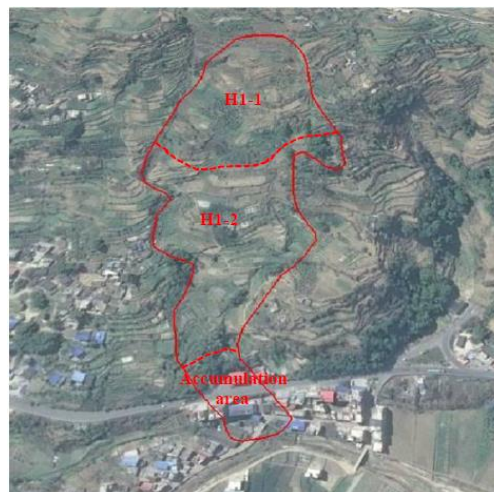
The landslide is located in three groups of Zhonghai Village. The original terrain is as follows: the upper part is a gentle slope with a slope of about 15–30°; the middle part is a steep slope with a slope of about 6–70°; the lower part is a slope with a slope of about 20–35°. It is convenient to analyze the deformation mechanism of landslide and divide the landslide before sliding (H1-1, H1-2).

Fig. 3 Division before landslide slip

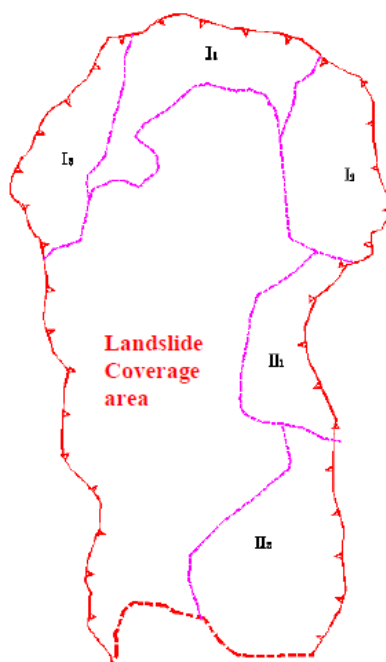
Landslide zoning from the landslide deformation and failure characteristics combined with the status quo of landslide zoning (Figure 8), divided into sliding area landslide and residual body of two large areas, the residual body is divided into  $I_1$ ,  $I_2$ ,  $I_3$ ,  $II_1$ ,  $II_2$  five sub-regions, sliding area for the early landslide sliding re-accumulation after the formation of new landslide, residual body according to the strength of the current deformation is divided into five sub-regions, including  $I_1$ ,  $I_2$ ,  $I_3$  for a landslide residual body,  $II_1$ ,  $II_2$  for secondary landslide residual body.

Fig. 8 Landslide zoning
